NARRATIVE END ITEM REPO
ON SATURN S-IVB - 503
(DAC S/N 1007)

MAY 1967
DOUGLAS REPORT DAC-56505

The Narrative End Item Report contained herein is a narrative summary of the Douglas manufacturing and test records relative to the Saturn S-IVB-AS-503 Flight Stage (Douglas P/N LA39300-503, S/N 1007).

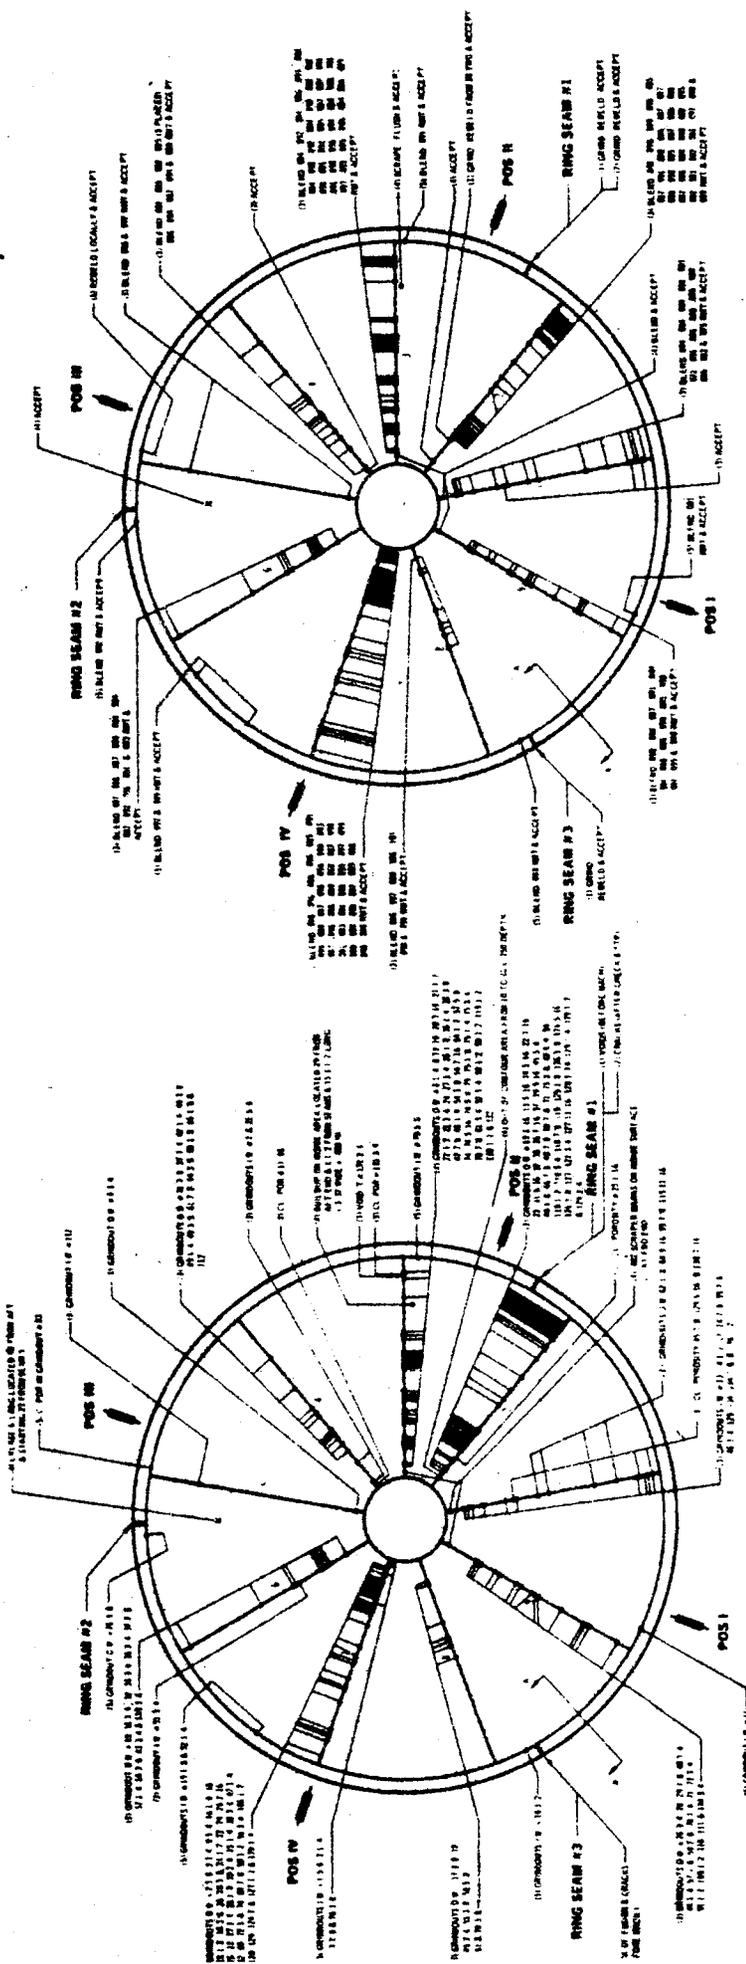
DEFECTS
VIEW LOOKING AFT

REWORKS
VIEW LOOKING AFT

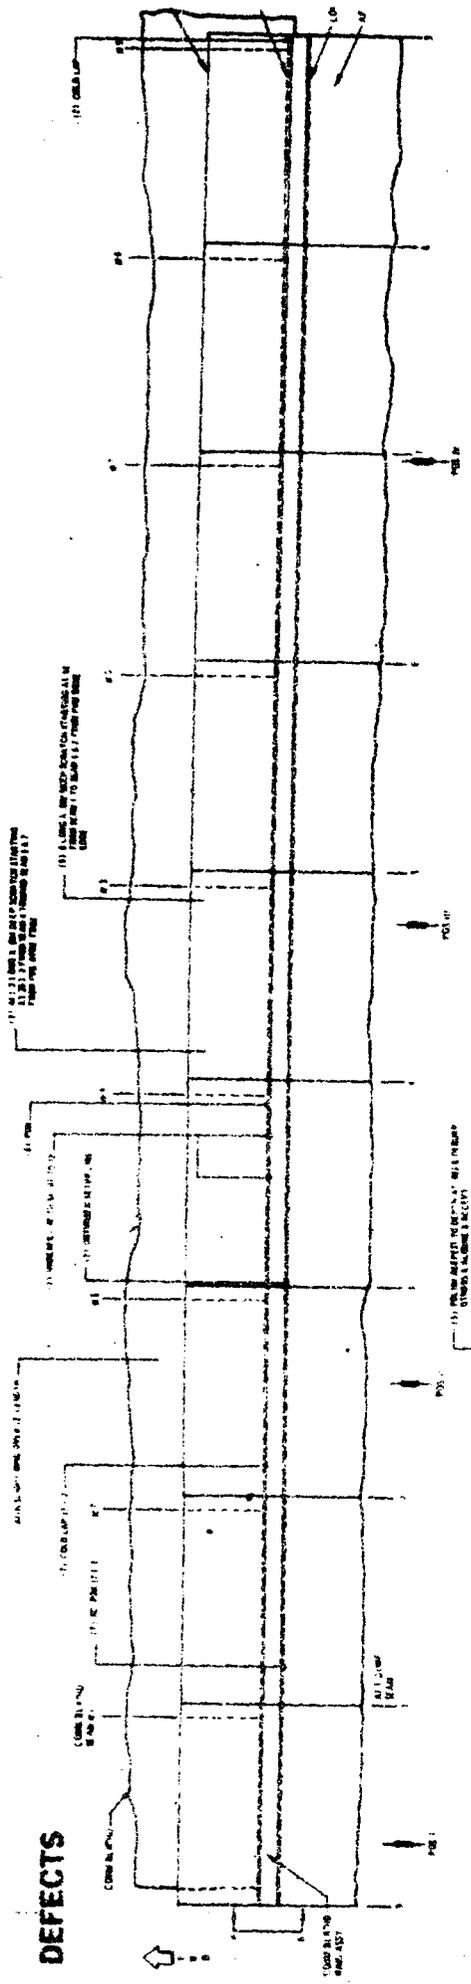
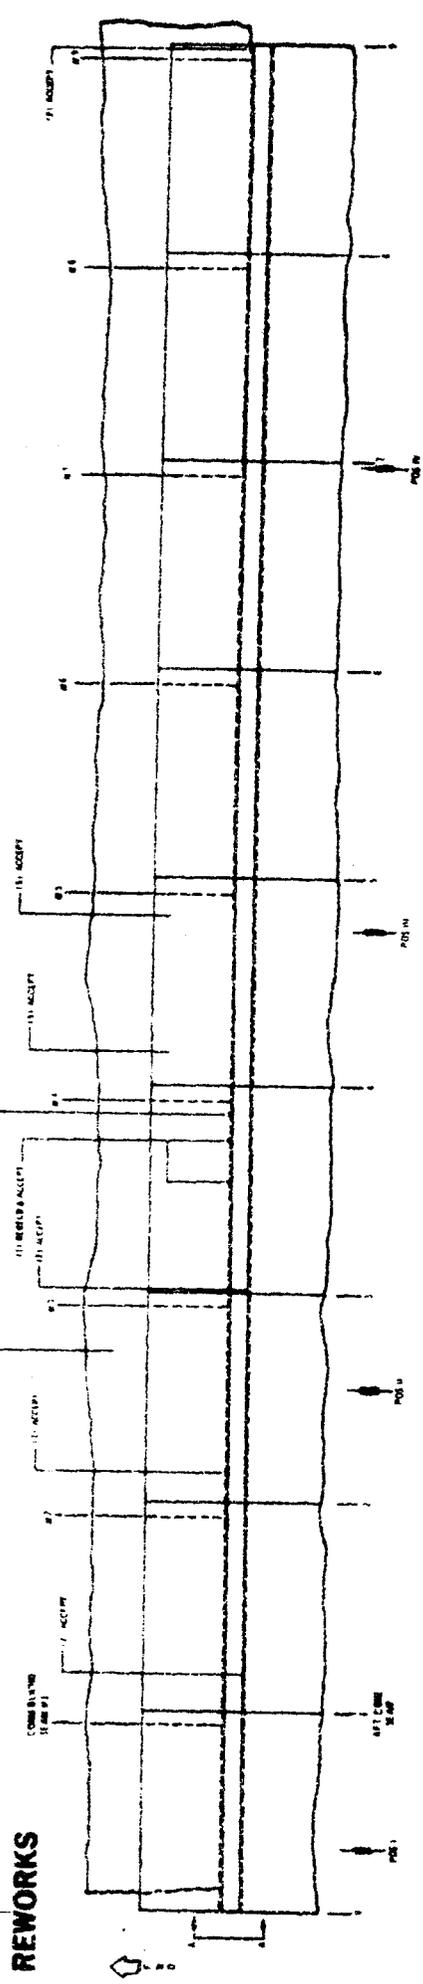
Chart 4. Forward Face Assembly

DEFECTS

REWORKS
